**Flood Control Project Maintenance  
Levee Inspections**

**Fall 2019 Levee Maintenance Deficiency Summary Report**

**San Joaquin River Basin**

**Flood Control Project Maintenance  
Levee Inspections****LMA District Cover Sheet****Fall 2019 Levee Inspection Results****Reclamation District No. 2031 Elliot**

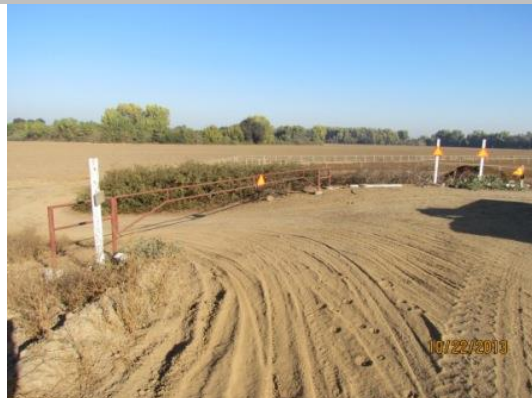
Photo 1 of 1 : FA\_2019\_RD2031\_307\_50\_20190830\_00015.jpg

LM Start	0.06	Rating **	M	Issue No.	50
LM End	0.06	Issue Type +	En	Location *	WS
Category	Earthen Levee			GPS Latitude/Longitude	
				Start	End
Item	Encroachments			37.709950°	37.709950°
				-121.156540°	-121.156540°
DWR ID	DWR_RD2031_01_f_2013_50				
Comment Code					
FE : Fence					
Inspector Comment					
There are metal cross gates at the waterside levee hinge.

View of the gate at the waterside levee hinge.

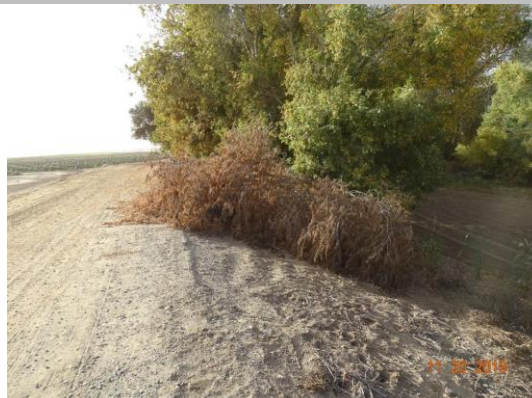
Photo 1 of 1 : FA\_2019\_RD2031\_307\_33\_20191120\_00090.jpg

LM Start	0.32	Rating **	M	Issue No.	33
LM End	0.32	Issue Type +	Ma	Location *	WS
Category	Earthen Levee			GPS Latitude/Longitude	
				Start	End
Item	Encroachments			37.706416 °	37.706416 °
				-121.157879 °	-121.157879 °
DWR ID	DWR_RD2031_01_f_2019_33				
Comment Code					
PR : Prunings					
Inspector Comment

View of prunings on waterside slope. Fall 2019

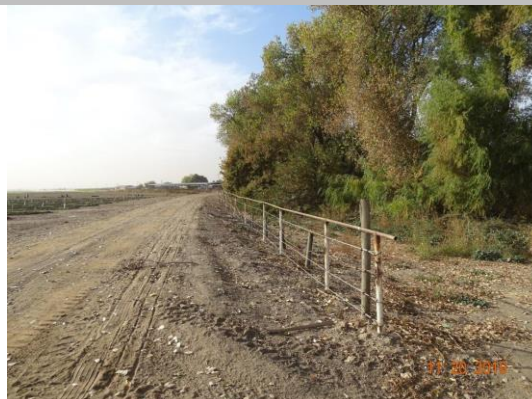
Photo 1 of 1 : FA\_2019\_RD2031\_307\_7\_20191120\_00091.jpg

LM Start	0.34	Rating **	M	Issue No.	7
LM End	0.51	Issue Type +	En	Location *	WS
Category	Earthen Levee			GPS Latitude/Longitude	
				Start	End
Item	Encroachments			37.706148°	37.704100°
				-121.157975°	-121.159553°
DWR ID	DWR_RD2031_01_s_2012_7				
Comment Code					
FE : Fence					
Inspector Comment

View of fence along waterside slope. Fall 2019

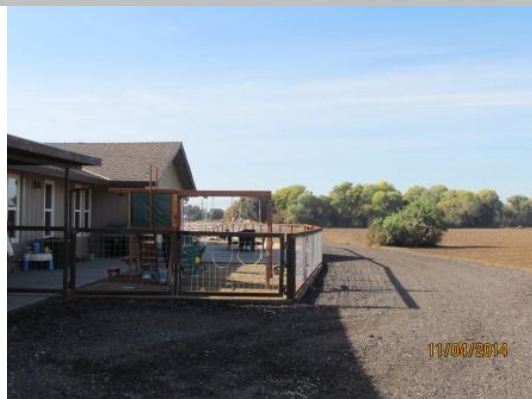
Photo 1 of 1 : FA\_2019\_RD2031\_307\_58\_20190830\_00019.jpg

LM Start	0.60	Rating **	M	Issue No.	58
LM End	0.63	Issue Type +	En	Location *	LS
Category	Earthen Levee			GPS Latitude/Longitude	
				Start	End
Item	Encroachments			37.703186 °	37.702786 °
				-121.160211 °	-121.160628 °
DWR ID	DWR_RD2031_01_f_2014_58				
Comment Code					
FE : Fence					
Inspector Comment

View of the unpermitted fence on the landside levee hinge.

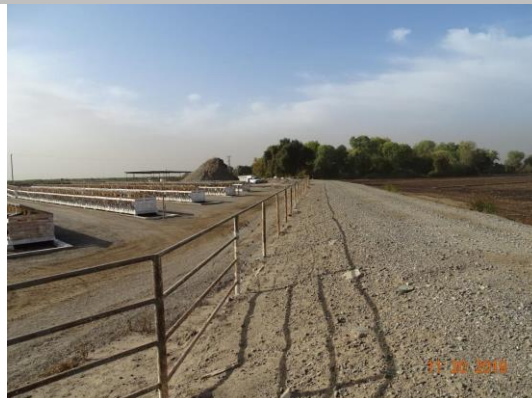
Photo 1 of 1 : FA\_2019\_RD2031\_307\_4\_20191120\_00092.jpg

LM Start	0.63	Rating **	M	Issue No.	4
LM End	0.70	Issue Type +	En	Location *	LS
Category	Earthen Levee			GPS Latitude/Longitude	
				Start	End
Item	Encroachments			37.702814 °	37.702126 °
				-121.160562 °	-121.161389 °
DWR ID	DWR_RD2031_01_s _ 2012_4				
Comment Code					
FE : Fence					
Inspector Comment

View of fence along landside slope. Fall 2019

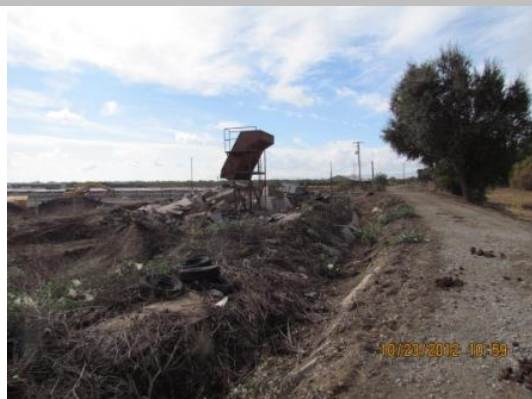
Photo 1 of 1 : FA\_2019\_RD2031\_307\_972\_20190830\_00026.jpg

LM Start	0.72	Rating **	M	Issue No.	972
LM End	0.76	Issue Type +	En	Location *	LS
Category	Earthen Levee			GPS Latitude/Longitude	
				Start	End
Item	Encroachments			37.701906°	37.701370°
				-121.161661°	-121.161986°
DWR ID	DWR_RD2031_01_s_2012_972				
Comment Code					
DT : Ditch					
Inspector Comment

View of the ditch on landside levee toe, facing downstream.

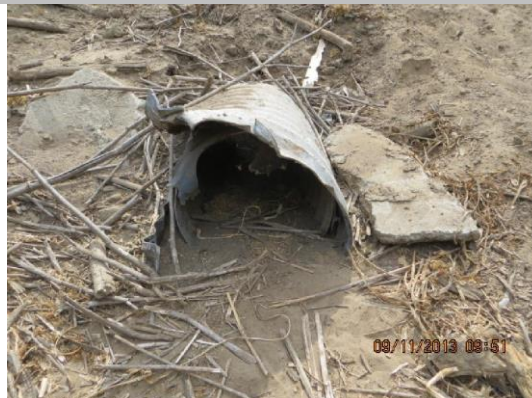
Photo 1 of 3 : UCIP\_FA\_2019\_20047\_33950.jpg

LM Start	0.75	Rating **	M	Issue No.	976
LM End	0.75	Issue Type +	En	Location *	
Category	Supplemental			GPS Latitude/Longitude	
				Start	End
Item	DRAFT DWR UCIP Field Study			37.701552°	37.701552°
				-121.161883°	-121.161883°
DWR ID	20441				
Comment Code					
Inspector Comment					
DS_ID:20441 FS_ID:20047 EP_NO: N/A Repair Type: Non-Urgent Crossing Status: Found UCIP Comments: This pipe appears abandoned and if so, should be done so appropriately. FIELD_STRUCT_DESC: 15-inch corrugated metal irrigation pipe through the levee, 4 feet below the crown. Flashboard slots on the landside (LS). Installed by USACE in 1966. [Additional Reference(s): DWR Levee Log, 2005. USACE San Joaquin O&M Manual 4, June 1968, (HLM 0.75)]. FS Date: 9/11/2013

Damaged CMP pipe on WS slope.

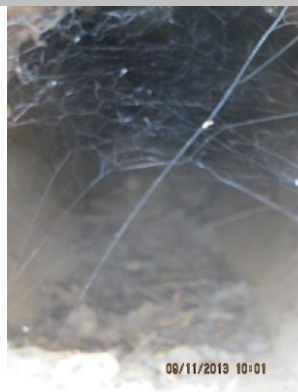
Photo 2 of 3 : UCIP\_FA\_2019\_20049\_33955.jpg

LM Start	0.80	Rating **	M	Issue No.	977
LM End	0.80	Issue Type +	En	Location *	
Category	Supplemental			GPS Latitude/Longitude	
				Start	End
Item	DRAFT DWR UCIP Field Study			37.700853 °	37.700853 °
				-121.162349 °	-121.162349 °
DWR ID	20443				
Comment Code					
Inspector Comment					
DS_ID:20443					
FS_ID:20049					
EP_NO: N/A					
Repair Type: Non-Urgent					
Crossing Status: Found					
UCIP Comments: Pipe appears abandoned as WS slope is covered with soil. If abandoned, it should be done so properly.					
FIELD_STRUCT_DESC: 24-inch steel irrigation pipe through the levee, 2 feet below the crown. Concrete headwalls on both sides of the levee crown. [Additional Reference(s): DWR Levee Log, 2005. USACE San Joaquin O&M Manual 4, June 1968, (HLM 0.81)].					
FS Date: 9/11/2013

Pipe not filled with concrete.

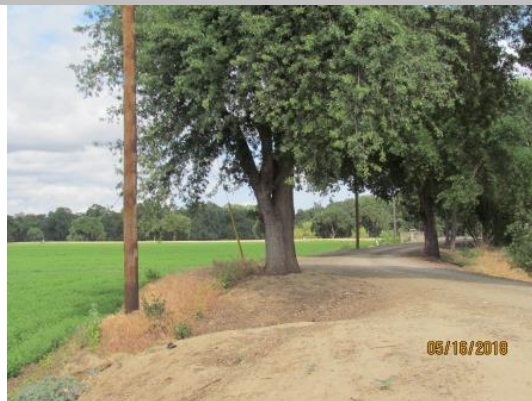
Photo 1 of 1 : FA\_2019\_RD2031\_307\_47\_20190830\_00012.jpg

LM Start	1.22	Rating **	M	Issue No.	47
LM End	1.22	Issue Type +	En	Location *	LS
Category	Earthen Levee			GPS Latitude/Longitude	
				Start	End
Item	Encroachments			37.699061 °	37.699061 °
				-121.169258 °	-121.169258 °
DWR ID	DWR_RD2031_01_s_2018_47				
Comment Code					
PO : Pole					
Inspector Comment

View looking downstream landside of three power poles on the levee and levee slope.

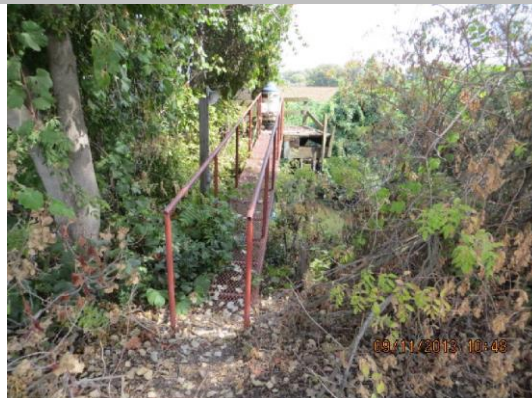
Photo 2 of 3 : UCIP\_FA\_2019\_20085\_34009.jpg

LM Start	<b>1.27</b>	Rating **	M	Issue No.	<b>979</b>
LM End	<b>1.27</b>	Issue Type +	En	Location *	
Category	Supplemental		GPS Latitude/Longitude		
			Start	End	
Item	DRAFT DWR UCIP Field Study		37.699480°	37.699480°	
			-121.169850°	-121.169850°	
DWR ID	20445				
Comment Code					
Inspector Comment					
DS_ID:20445 FS_ID:20085 EP_NO: N/A Repair Type: Non-Urgent Crossing Status: Found UCIP Comments: Pipe corroded through at distribution box. Appears abandoned and should be done so properly. FIELD_STRUCT_DESC: 1 of 2: 12-inch steel irrigation pipe through the levee, 3.3 feet below the crown. Pump missing from pile structure on the riverbank. Concrete distribution box on the landside (LS). Installed by USACE in 1966. [Additional Reference(s): DWR Levee Log, 2005. USACE San Joaquin O&M Manual 4, June 1968, (HLM 1.28)]. FS Date: 9/11/2013

Pump on pier on WS slope.

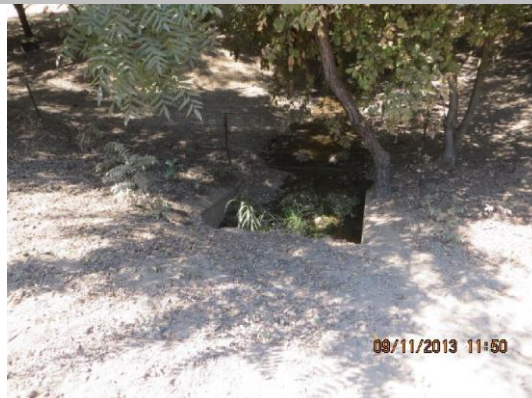
Photo 1 of 3 : UCIP\_FA\_2019\_41354\_34034.jpg

LM Start	1.78	Rating **	M	Issue No.	981
LM End	1.78	Issue Type +	Ma	Location *	
Category	Supplemental			GPS Latitude/Longitude	
				Start	End
Item	DRAFT DWR UCIP LMA Responsibility			37.696958 °	37.696958 °
				-121.177464 °	-121.177464 °
DWR ID	20470				
Comment Code					
Inspector Comment					
DS_ID:20470 FS_ID:41354 EP_NO: N/A Repair Type: Non-Urgent Crossing Status: Found UCIP Comments: Silt buildup at inlet and outlet. FIELD_STRUCT_DESC: 1 of 2: 24-inch corrugated metal drainage pipe through the levee, 9.5 feet below the crown. Concrete U-shaped headwalls on both ends. Flap gate on the waterside (WS) end. Installed by USACE in 1966. [Additional Reference(s): DWR Levee Log, 2005. USACE San Joaquin O&M Manual 4, June 1968, (HLM 1.80)]. FS Date: 9/11/2013

Concrete headwall on WS toe.

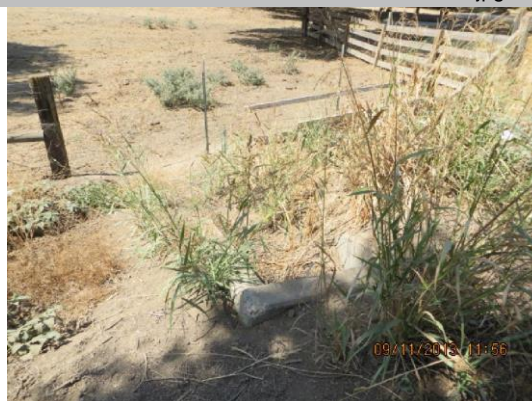
Photo 1 of 3 : UCIP\_FA\_2019\_20109\_34075.jpg

LM Start	1.86	Rating **	M	Issue No.	983
LM End	1.86	Issue Type +	En	Location *	
Category	Supplemental			GPS Latitude/Longitude	
				Start	End
Item	DRAFT DWR UCIP Field Study			37.695737°	37.695737°
				-121.177533°	-121.177533°
DWR ID	20448				
Comment Code					
Inspector Comment					
DS_ID:20448 FS_ID:20109 EP_NO: N/A Repair Type: Non-Urgent Crossing Status: Found UCIP Comments: If abandoned it should be done so properly if not, the pipe should be cleared of soil blockage. FIELD_STRUCT_DESC: *ABANDONED* 24-inch drainage pipe of an unknown material through the levee, 6.8 feet below the crown. Concrete headwalls on both ends. Flap gate on the waterside (WS) end. Installed by USACE in 1966. [Additional Reference(s): DWR Levee Log, 2005. USACE San Joaquin O&M Manual 4, June 1968]. FS Date: 9/11/2013

Concrete U-shaped headwall on WS toe.

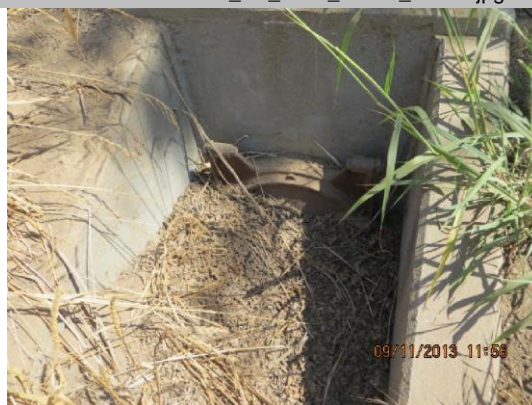
Photo 2 of 3 : UCIP\_FA\_2019\_20109\_34074.jpg

Flapgate on WS toe.

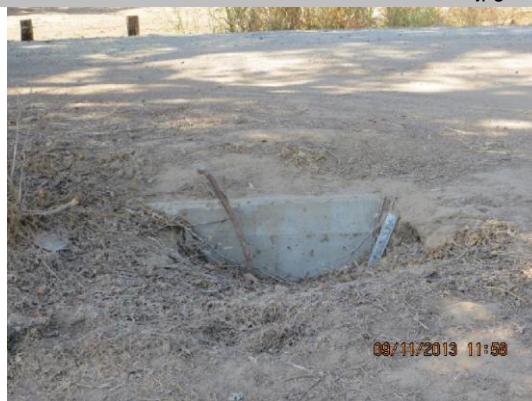
Photo 3 of 3 : UCIP\_FA\_2019\_20109\_34073.jpg

LM Start	1.86	Rating **	M	Issue No.	983 (cont)	
LM End	1.86	Issue Type +	En	Location *		
Category	Supplemental			GPS Latitude/Longitude		
				Start		End
Item	DRAFT DWR UCIP Field Study			37.695737 °		37.695737 °
				-121.177533 °		-121.177533 °
DWR ID	20448					
Comment Code						
Inspector Comment						
DS_ID:20448 FS_ID:20109 EP_NO: N/A Repair Type: Non-Urgent Crossing Status: Found UCIP Comments: If abandoned it should be done so properly if not, the pipe should be cleared of soil blockage. FIELD_STRUCT_DESC: *ABANDONED* 24-inch drainage pipe of an unknown material through the levee, 6.8 feet below the crown. Concrete headwalls on both ends. Flap gate on the waterside (WS) end. Installed by USACE in 1966. [Additional Reference(s): DWR Levee Log, 2005. USACE San Joaquin O&M Manual 4, June 1968]. FS Date: 9/11/2013

Concrete headwall on LS shoulder.

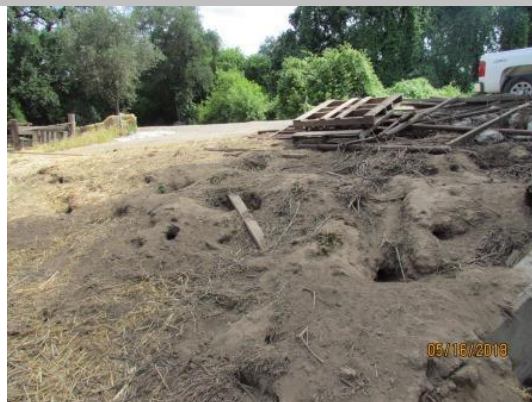
Photo 1 of 1 : FA\_2019\_RD2031\_307\_49\_20190830\_00014.jpg

LM Start	1.86	Rating **	M	Issue No.	49
LM End	1.86	Issue Type +	Ma	Location *	WS
Category	Earthen Levee			GPS Latitude/Longitude	
				Start	End
Item	Animal Control			37.695736°	37.695736°
				-121.177530°	-121.177530°
DWR ID	DWR_RD2031_01_s_2018_49				
Comment Code					
A1 : Exterminate rodents and backfill and compact or grout burrows.					
Inspector Comment					
Several squirrel holes and active rodent activity still exist in this location.

View of the waterside where several squirrel holes are and active rodent activity.

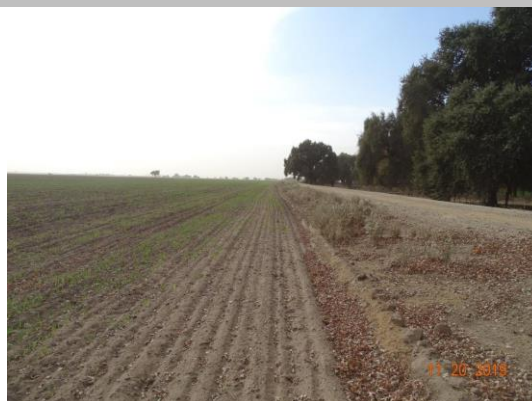
Photo 1 of 1 : FA\_2019\_RD2031\_307\_62\_20191120\_00093.jpg

LM Start	1.87	Rating **	M	Issue No.	62
LM End	2.34	Issue Type +	En	Location *	LS
Category	Earthen Levee			GPS Latitude/Longitude	
				Start	End
Item	Encroachments			37.695594 °	37.689135 °
				-121.177532 °	-121.179123 °
DWR ID	DWR_RD2031_01_f_2019_62				
Comment Code					
CR : Crops					
Inspector Comment

View of crops along landside easement. Fall 2019

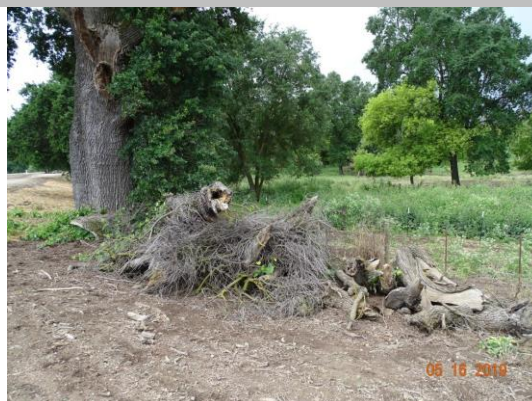
Photo 1 of 1 : FA\_2019\_RD2031\_307\_42\_20190830\_00011.jpg

LM Start	2.06	Rating **	U	Issue No.	42
LM End	2.06	Issue Type +	Ma	Location *	WS
Category	Earthen Levee			GPS Latitude/Longitude	
				Start	End
Item	Encroachments			37.692896 °	37.692896 °
				-121.177506 °	-121.177506 °
DWR ID	DWR_RD2031_01_s_2019_42				
Comment Code					
PR : Prunings					
Inspector Comment

View of prunings on waterside slope. (Spring 2019)

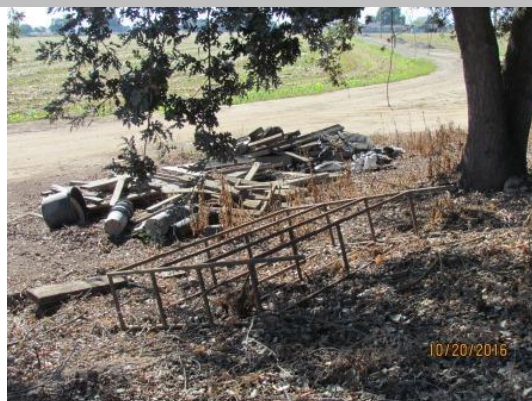
Photo 1 of 2 : FA\_2019\_RD2031\_307\_53\_20190830\_00016.jpg

LM Start	2.40	Rating **	M	Issue No.	53
LM End	2.44	Issue Type +	En	Location *	LS
Category	Earthen Levee			GPS Latitude/Longitude	
				Start	End
Item	Encroachments			37.688465 °	37.688064 °
				-121.179821 °	-121.180175 °
DWR ID	DWR_RD2031_01_s_2015_53				
Comment Code					
DE : Debris					
Inspector Comment

View of the debris at the landside levee toe.

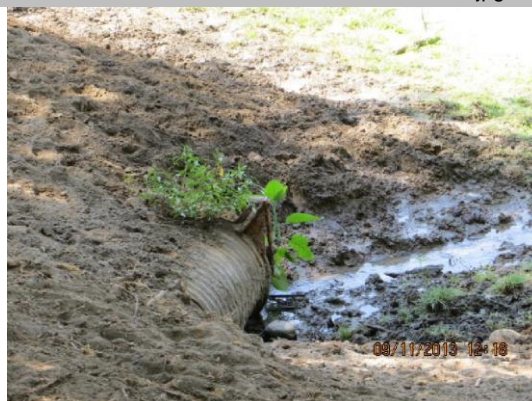
Photo 1 of 3 : UCIP\_FA\_2019\_51340\_39002.jpg

Flapgate and pipe visible on WS toe.

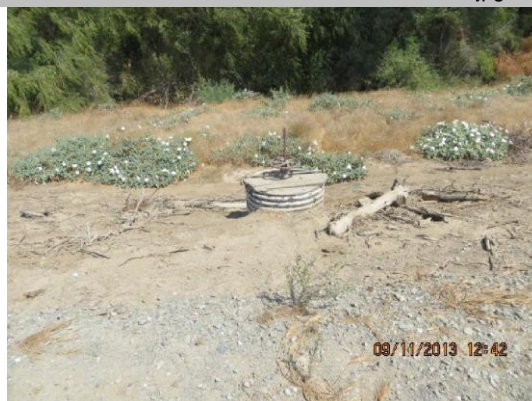
Photo 1 of 3 : UCIP\_FA\_2019\_20449\_34506.jpg

LM Start	3.08	Rating **	M	Issue No.	986
LM End	3.08	Issue Type +	Ma	Location *	
Category	Supplemental			GPS Latitude/Longitude	
				Start	End
Item	DRAFT DWR UCIP LMA Responsibility			37.688297 °	37.688297 °
				-121.190865 °	-121.190865 °
DWR ID	20451				
Comment Code					
Inspector Comment					
DS_ID:20451					
FS_ID:20449					
EP_NO: N/A					
Repair Type: Non-Urgent					
Crossing Status: Found					
UCIP Comments: Pipe appears to be abandoned and if so should be done so properly.					
FIELD_STRUCT_DESC: *ABANDONED* 24-inch corrugated metal drainage pipe through the levee, 14 feet below the crown. Slide gate in a 36-inch corrugated metal pipe (CMP) riser on the waterside (WS) slope. [Additional Reference(s): DWR Levee Log, 2005. USACE San Joaquin O&M Manual 4, June 1968, (HLM 3.11)].					
FS Date: 9/11/2013

Slide gate in CMP riser on WS slope.

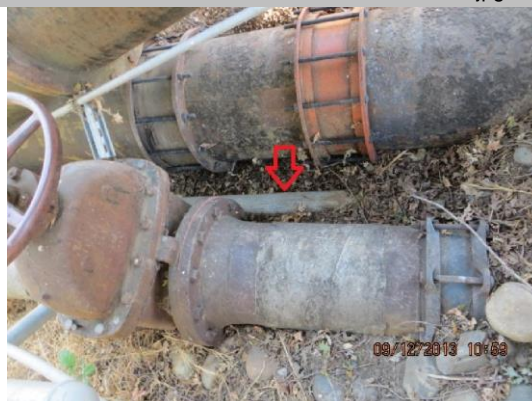
Photo 1 of 2 : UCIP\_FA\_2019\_22843\_39015.jpg

Pipe visible between larger irrigation pipes below slant pump on WS slope.

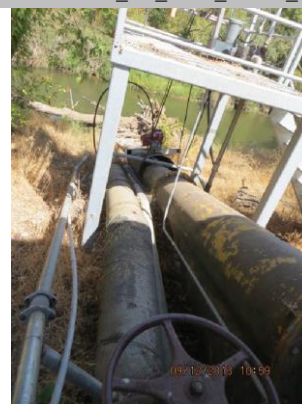
Photo 2 of 2 : UCIP\_FA\_2019\_22843\_39014.jpg

Pipe visible between larger irrigation pipes below slant pump on WS slope.

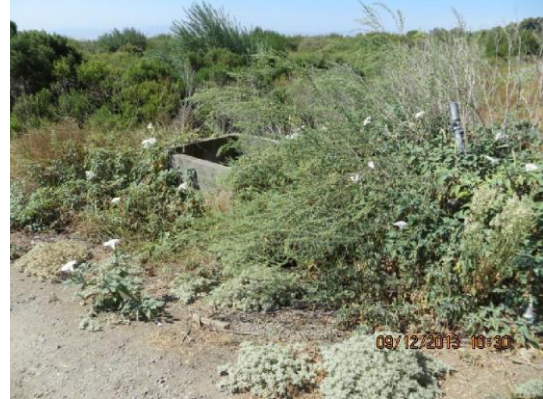
Photo 1 of 3 : UCIP\_FA\_2019\_20667\_34750.jpg

Comment Code						
Inspector Comment						
DS_ID:20456 FS_ID:20667 EP_NO: N/A Repair Type: Non-Urgent Crossing Status: Found UCIP Comments: Siphon breaker missing from LS shoulder. Fish screen and pipe end covered in debris that may cause damage to pipe. FIELD_STRUCT_DESC: 1 of 2: 20-inch steel irrigation pipe through the levee, 3.9 feet below the crown. Slant pump in pump house mounted on piles on the berm. Siphon breaker in a corrugated metal pipe (CMP) riser on the landside (LS) shoulder. Service pole on the LS slope. 5-foot by 5-foot concrete distribution box on the LS toe with flap gate. [Additional Reference(s): DWR Levee Log, 2005. USACE San Joaquin O&M Manual 4, June 1968, (HLM 3.70)]. FS Date: 9/12/2013

Concrete distribution box on LS slope.

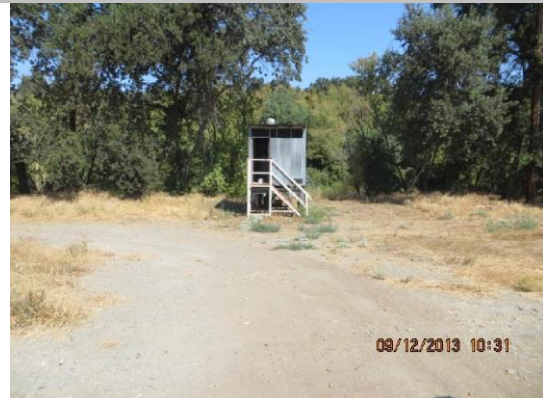
Photo 2 of 3 : UCIP\_FA\_2019\_20667\_34749.jpg

Slant pump in pumphouse on WS berm.

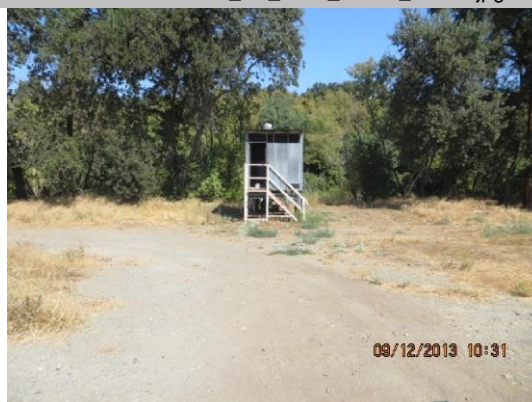
Photo 1 of 3 : UCIP\_FA\_2019\_22845\_39021.jpg

LM Start	3.69	Rating **	M	Issue No.	990
LM End	3.69	Issue Type +	En	Location *	
Category	Supplemental			GPS Latitude/Longitude	
				Start	End
Item	DRAFT DWR UCIP Field Study			37.689757 °	37.689757 °
				-121.198804 °	-121.198804 °
DWR ID	24671				
Comment Code					
Inspector Comment					
DS_ID:24671 FS_ID:22845 EP_NO: N/A Repair Type: Non-Urgent Crossing Status: Found UCIP Comments: No permit identified for this possible crossing. FIELD_STRUCT_DESC: 2.5-inch galvanized iron irrigation pipe through the levee, at an unknown depth. Submersible pump on the waterside (WS) slope. FS Date: 9/12/2013

Pipe visible on WS of pumphouse.

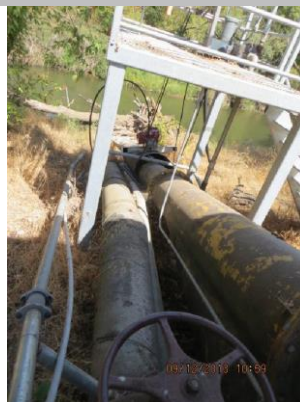
Photo 3 of 3 : UCIP\_FA\_2019\_22845\_39019.jpg

Pipe and appurtenances visible on downstream side of and next to larger irrigation pipe.

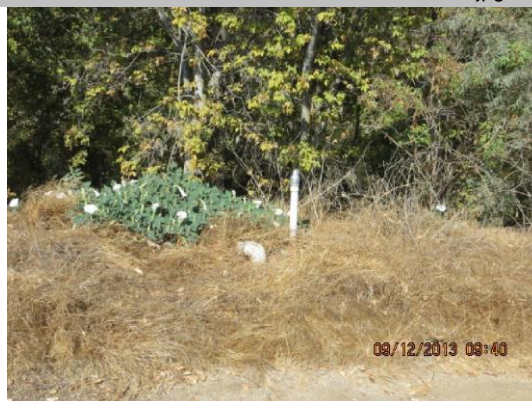
Photo 1 of 2 : UCIP\_FA\_2019\_22846\_39023.jpg

LM Start	4.40	Rating **	M	Issue No.	991
LM End	4.40	Issue Type +	En	Location *	
Category	Supplemental			GPS Latitude/Longitude	
				Start	End
Item	DRAFT DWR UCIP Field Study			37.686500 °	37.686500 °
				-121.207900 °	-121.207900 °
DWR ID	24673				
Comment Code					
Inspector Comment					
DS_ID:24673					
FS_ID:22846					
EP_NO: N/A					
Repair Type: Non-Urgent					
Crossing Status: Found					
UCIP Comments: No permit identified for this possible crossing.					
FIELD_STRUCT_DESC: 4-inch galvanized iron irrigation pipe visible on the waterside (WS) shoulder. Pipe may go through the levee, at an unknown depth. Vent on the WS shoulder.					
FS Date: 9/12/2013

Pipe and vent visible on WS shoulder.

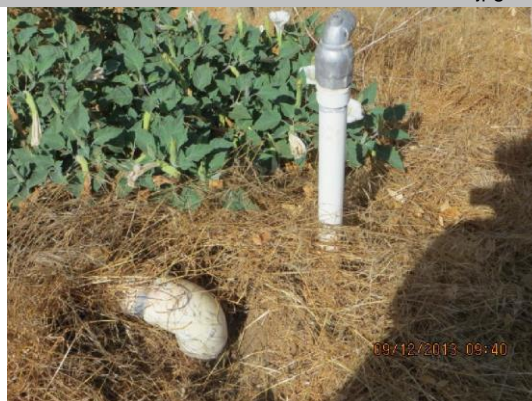
Photo 2 of 2 : UCIP\_FA\_2019\_22846\_39022.jpg

Pipe and vent visible on WS shoulder.

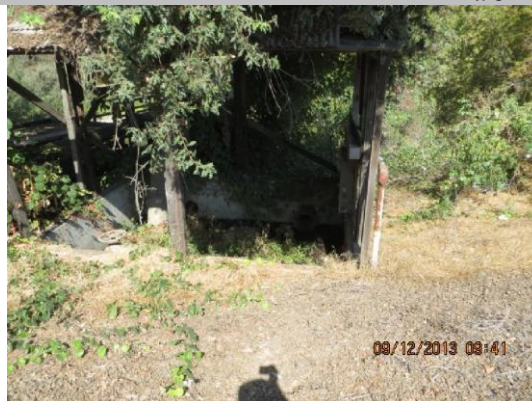
Photo 1 of 3 : UCIP\_FA\_2019\_20683\_34782.jpg

LM Start	4.41	Rating **	A/W	Issue No.	992
LM End	4.41	Issue Type +	Ma	Location *	
Category	Supplemental			GPS Latitude/Longitude	
				Start	End
Item	DRAFT DWR UCIP LMA Responsibility			37.686290 °	37.686290 °
				-121.208000 °	-121.208000 °
DWR ID	20458				
Comment Code					
Inspector Comment					
DS_ID:20458 FS_ID:20683 EP_NO: N/A Repair Type: No Action Needed Crossing Status: Found UCIP Comments: FIELD_STRUCT_DESC: *ABANDONED* 1 of 2: 14-inch concrete encased steel drainage pipe through the levee, 7.5 feet below the crown. Plate welded on the waterside (WS) end. 6-foot by 12-foot concrete distribution box on the landside (LS) toe. [Additional Reference(s): DWR Levee Log, 2005. USACE San Joaquin O&M Manual 4, June 1968, (HLM 4.46)]. FS Date: 9/12/2013

Pipe visible inside pumphouse on WS slope.

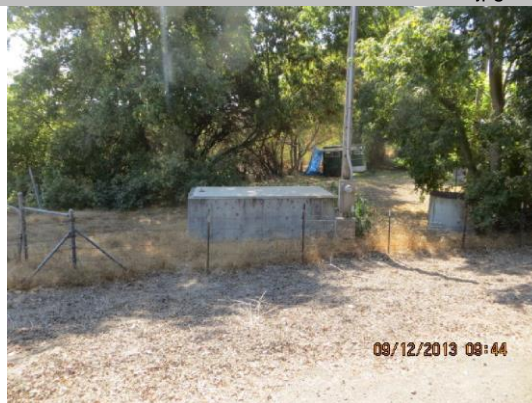
Photo 3 of 3 : UCIP\_FA\_2019\_20683\_34780.jpg

Concrete distribution box on LS toe.

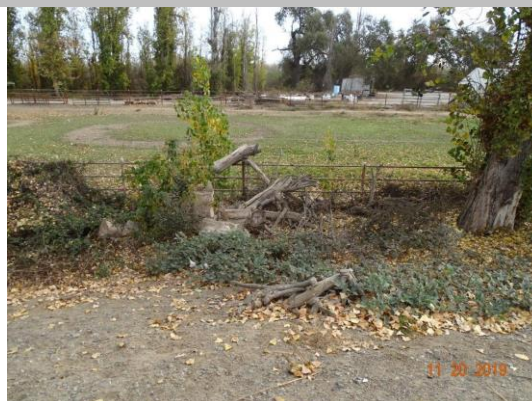
Photo 1 of 1 : FA\_2019\_RD2031\_307\_67\_20191120\_00094.jpg

LM Start	4.50	Rating **	M	Issue No.	67
LM End	4.50	Issue Type +	Ma	Location *	LS
Category	Earthen Levee			GPS Latitude/Longitude	
				Start	End
Item	Encroachments			37.685220°	37.685220°
				-121.208386°	-121.208386°
DWR ID	DWR_RD2031_01_f_2019_67				
Comment Code					
PR : Prunings					
Inspector Comment

View of prunings on landside slope. Fall 2019

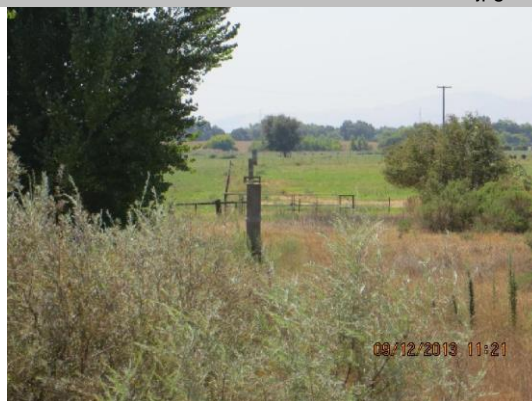
Photo 1 of 2 : UCIP\_FA\_2019\_20688\_34799.jpg

Concrete standpipes visible in field off LS toe.

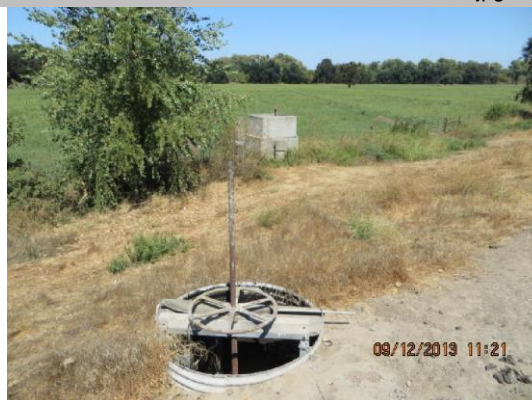
Photo 2 of 2 : UCIP\_FA\_2019\_20688\_34798.jpg

Comment Code						
Inspector Comment						
DS_ID:20461						
FS_ID:20688						
EP_NO: N/A						
Repair Type: Non-Urgent						
Crossing Status: Found						
UCIP Comments: CMP riser on WS slope is missing lid and may be a hazard.						
FIELD_STRUCT_DESC: 36-inch corrugated metal irrigation pipe through the levee, 11 feet below the crown. Slide gate in a 48-inch corrugated metal pipe (CMP) riser on the waterside (WS) slope. 5-foot by 5-foot concrete distribution box, 10 feet from the WS toe.						
Underground irrigation system on the landside (LS) with concrete standpipes visible in field. [Additional Reference(s): DWR Levee Log, 2005. USACE San Joaquin O&M Manual 4, June 1968, (HLM 5.02)].						
FS Date: 9/12/2013

Slide gate in CMP riser on WS shoulder with concrete distribution box visible in background at WS toe.

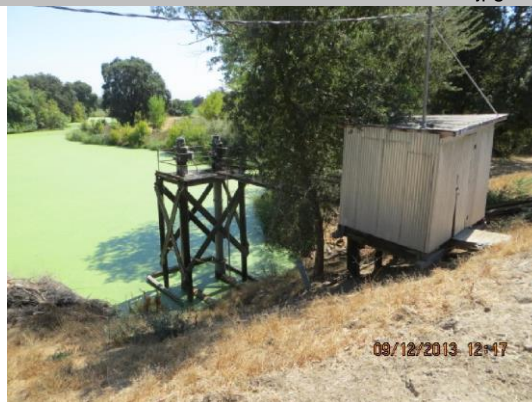
Photo 1 of 3 : UCIP\_FA\_2019\_20703\_34822.jpg

Pump on platform at LS toe.

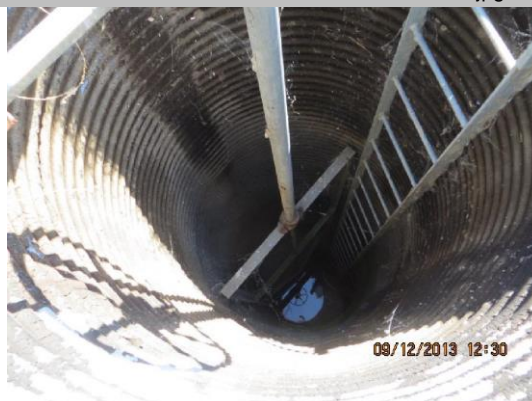
Photo 2 of 3 : UCIP\_FA\_2019\_53836\_34834.jpg

Comment Code						
Inspector Comment						
DS_ID:20484						
FS_ID:53836						
EP_NO: N/A						
Repair Type: Non-Urgent						
Crossing Status: Found						
UCIP Comments: 05/17/2018 LMA installed lid on top of riser (D. Sanoski - DWR UCIP).						
FIELD_STRUCT_DESC: 48-inch corrugated metal drainage pipe through the levee, 22.8 feet below the crown. Slide gate in a 5-foot-diameter corrugated metal pipe (CMP) riser on the waterside (WS) slope. Concrete U-shaped headwalls on both ends. Flap gate on the WS end. [Additional Reference(s): DWR Levee Log, 2005. USACE San Joaquin O&M Manual 4, June 1968, (HLM 0.26)].						
FS Date: 5/17/2018

Slide gate in CMP riser on WS slope.

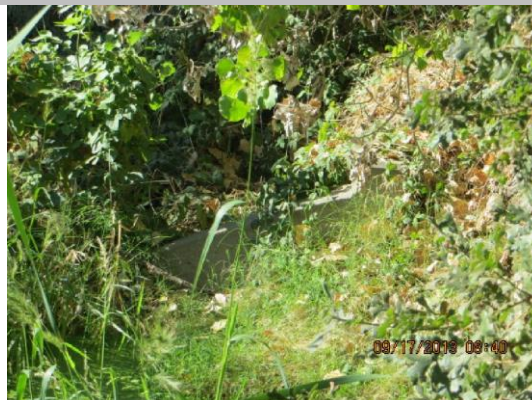
Photo 3 of 3 : UCIP\_FA\_2019\_53836\_34833.jpg

Concrete headwall on LS toe at edge of pond.

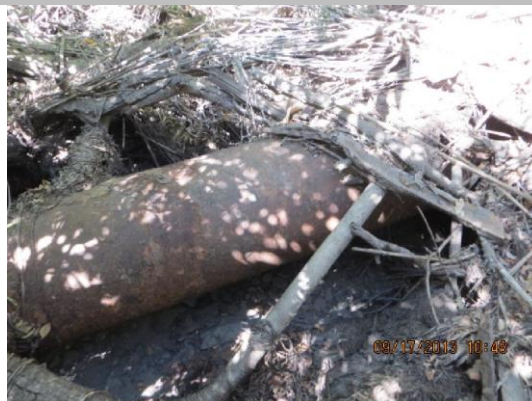
Photo 1 of 3 : UCIP\_FA\_2019\_20713\_34838.jpg

Comment Code					
Inspector Comment					
DS_ID:20490 FS_ID:20713 EP_NO: 11758 Repair Type: Non-Urgent Crossing Status: Found UCIP Comments: Pipe rusted through and failing at WS toe. Good indicator of internal condition of pipe. Good candidate for video inspection. FIELD_STRUCT_DESC: 24-inch corrugated metal gravity drainage pipe through the levee, 17 feet below the crown. 20-inch steel pipe and 1.25-inch galvanized conduit sleeved through the 24-inch pipe. Annular space pressure grouted. Slide gate in a 48-inch corrugated metal pipe (CMP) riser on the landside (LS) slope. 36-inch concrete standpipe at the LS toe with pump on a 48-inch steel standpipe. (20-inch and 1.5-inch pipes installed under Permit No. 11758, 1976 - Faith Ranch). [Additional Reference(s): DWR Levee Log, 2005. USACE San Joaquin O&M Manual 4, June 1968, (HLM 2.75)]. FS Date: 9/17/2013

Pipe visible on LS toe.

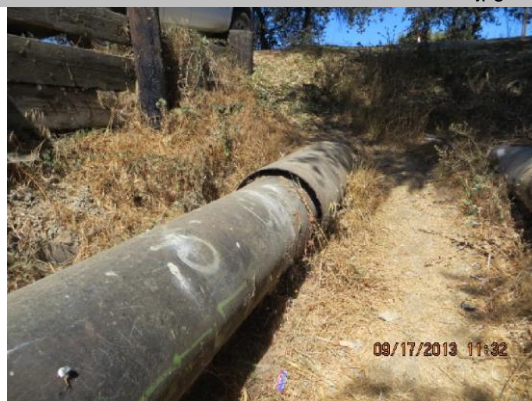
Photo 1 of 3 : UCIP\_FA\_2019\_20719\_34860.jpg

24-inch with 20-inch sleeved through it.

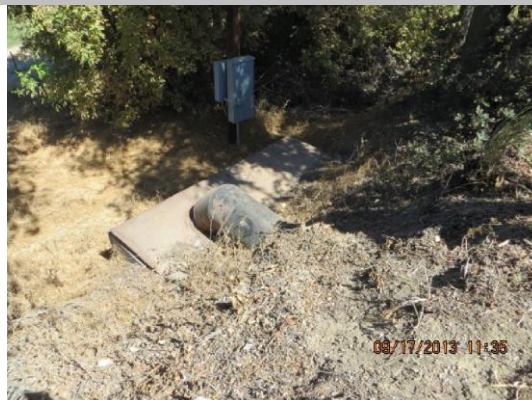
Photo 2 of 3 : UCIP\_FA\_2019\_20719\_34859.jpg

Concrete distribution box on LS slope.

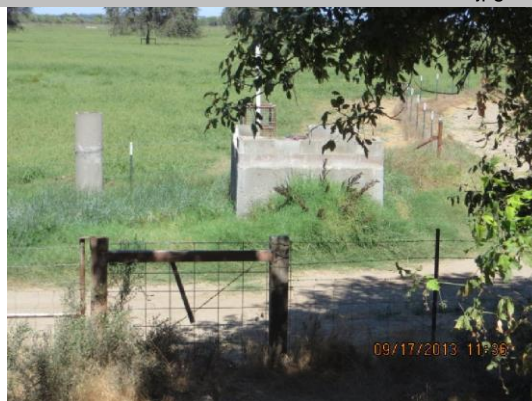
Photo 3 of 3 : UCIP\_FA\_2019\_20719\_34858.jpg

Concrete distribution box off LS toe.

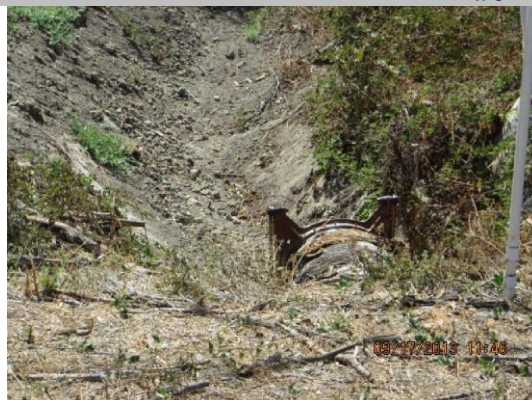
Photo 1 of 3 : UCIP\_FA\_2019\_20723\_34882.jpg

Flap gate on CMP pipe at WS toe.

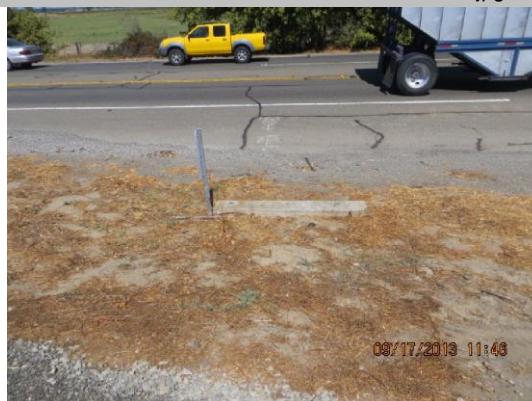
Photo 2 of 3 : UCIP\_FA\_2019\_20723\_34881.jpg

Concrete headwall on LS toe.

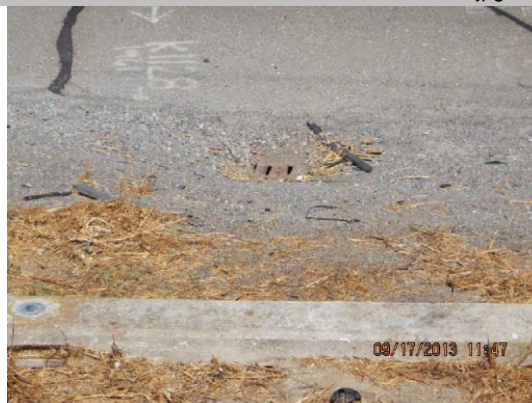
Photo 3 of 3 : UCIP\_FA\_2019\_20723\_34880.jpg

Drop inlet on LS toe.

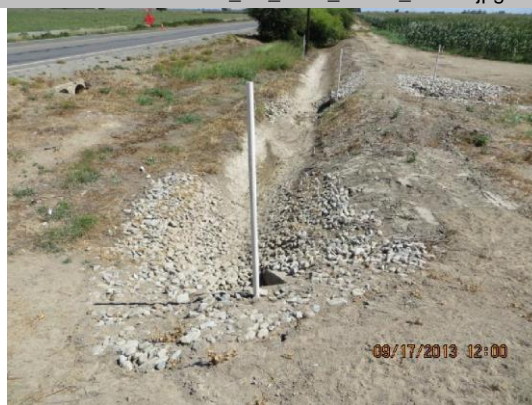
Photo 1 of 3 : UCIP\_FA\_2019\_51374\_34886.jpg

Comment Code					
Inspector Comment					
DS_ID:20496 FS_ID:51374 EP_NO: N/A Repair Type: No Action Needed Crossing Status: Found UCIP Comments: 11/16/2016 Crossing has been downgraded from Urgent to No Action Needed debris has been cleared from both WS and LS. (O. Magana - DWR UCIP)09/17/2013 Minor debris blocking closure of flapgate on WS toe. (W. Wylie - DWR UCIP) FIELD_STRUCT_DESC: 24-inch corrugated metal drainage pipe through the levee, 11 feet below the crown. Concrete U-shaped headwalls on each end. Flap gate on the waterside (WS) end. [Additional Reference(s): DWR Levee Log, 2005. USACE San Joaquin O&M Manual 4, June 1968, (HLM 3.88), Drawing No. 07-04-1666, Sheets 1666/23 and 1666/53, (Station 2+38S.T)]. FS Date: 11/16/2016

Concrete headwall on LS toe.

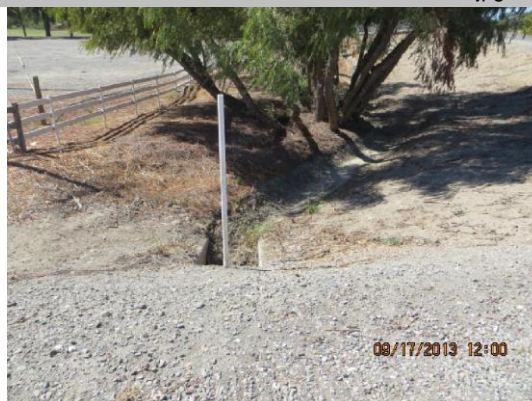
Photo 2 of 3 : UCIP\_FA\_2019\_51374\_34885.jpg

Concrete headwall on WS toe.

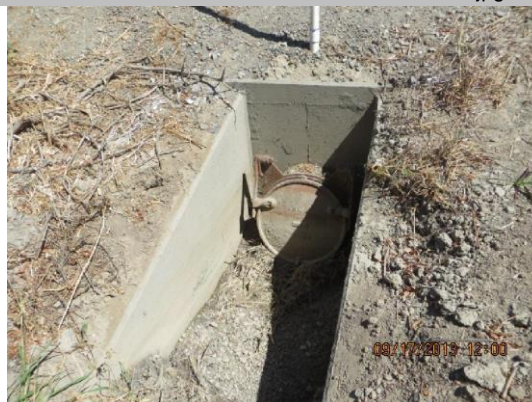
Photo 3 of 3 : UCIP\_FA\_2019\_51374\_34884.jpg

Flapgate on WS toe.

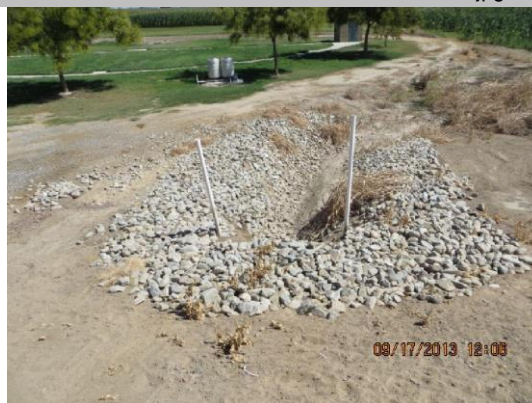
Photo 1 of 3 : UCIP\_FA\_2019\_20728\_34895.jpg

Concrete headwall at ditch on LS toe.

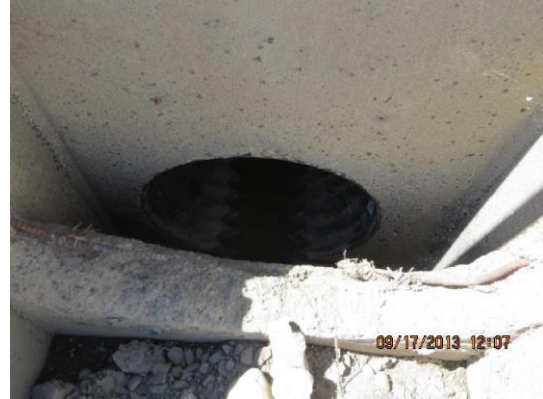
Photo 2 of 3 : UCIP\_FA\_2019\_20728\_34894.jpg

Concrete headwall on LS toe.

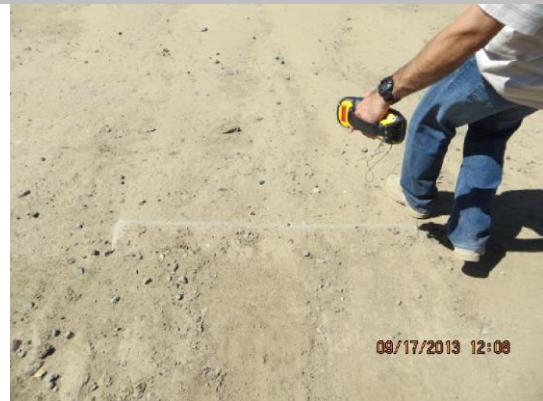
Photo 3 of 3 : UCIP\_FA\_2019\_20728\_34893.jpg

Headwall on WS toe.

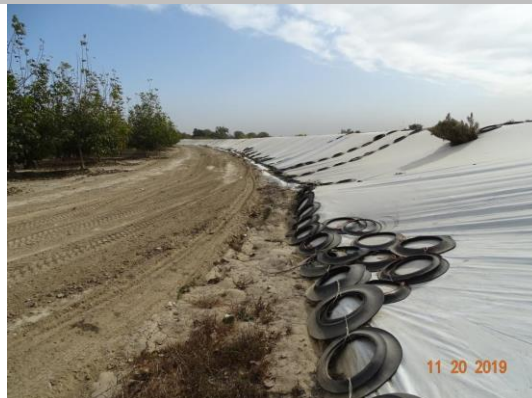
Photo 3 of 4 : FA\_2019\_RD2031\_308\_16\_20191120\_00041.jpg

LM Start	4.22	Rating **	U	Issue No.	16 (cont)	
LM End	4.51	Issue Type +	En	Location *	CR	
Category	Earthen Levee			GPS Latitude/Longitude		
				Start		End
Item	Encroachments			37.632503°	37.630917°	
				-121.190603°	-121.185895°	
DWR ID	DWR_RD2031_02_s_2019_16					
Comment Code						
MA : Material						
Inspector Comment						
Visqueen was installed in 2017 on the waterside, the crown, and the landside of the levee. Material does not allow for an evaluation of levee. Recommend removing material prior to next inspection.

View of visqueen on landside slope. Fall 2019

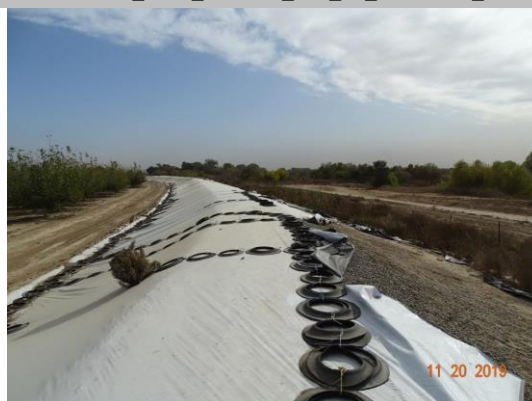
Photo 4 of 4 : FA\_2019\_RD2031\_308\_16\_20191120\_00042.jpg

View of visqueen on crown and landside slope. Fall 2019

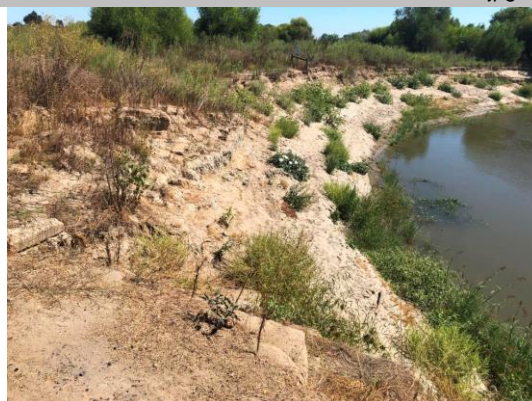
Photo 1 of 3 : SJR2019\_RD2031U02RM78.7\_1.jpg

Site ID: RD2031U02RM78.7  
 09/17/2019: No significant change was observed. The levee slopes near the site are covered with protecting sheets.  
 10/04/2017: The erosion in the berm again was found further progressed toward levee toe.  
 07/08/2016: The erosion in the berm was found further progressed toward levee toe.  
 08/19/2015: No significant change observed.  
 07/17/2014: The erosion has slightly expanded toward levee toe at two pocket locations.  
 09/10/2013: The site has been visited. The erosion has expanded toward levee crest at two pocket locations.  
 07/18/2012: No significant change observed on the site.  
 08/18/2011: No significant change observed on the site. Dead trees and animal activities are visible. The closest point of the erosion site to the levee toe is about 100 ft.  
 10/19/2010: There is active scouring occurring on the bank due to the nature of the flow and the lack of armor protection. There is also a fallen log immediately downstream of where the erosion has occurred and is protruding outward, possibly creating an eddy and scouring the bank. With the remaining 100-foot wide berm, the levee prism is not yet affected. However, the bank will continue to degrade, and eventually intrude into the levee prism if no protection is put in place. Erosion site is recommended for annual assessment and monitoring during flood events.

Looking upstream of the erosion site.

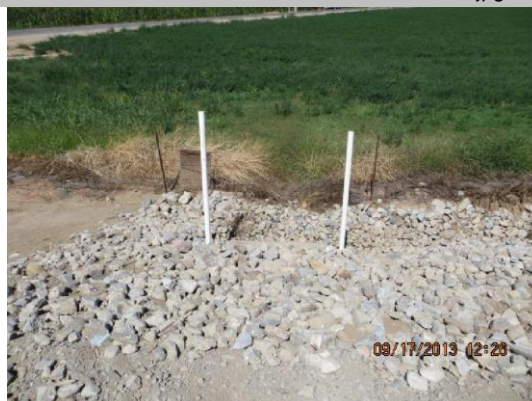
Photo 1 of 3 : UCIP\_FA\_2019\_22872\_39036.jpg

LM Start	4.70	Rating **	M	Issue No.	976
LM End	4.70	Issue Type +	En	Location *	
Category	Supplemental			GPS Latitude/Longitude	
				Start	End
Item	DRAFT DWR UCIP Field Study			37.630815 °	37.630815 °
				-121.182416 °	-121.182416 °
DWR ID	24676				
Comment Code					
Inspector Comment					
DS_ID:24676 FS_ID:22872 EP_NO: N/A Repair Type: Non-Urgent Crossing Status: Found UCIP Comments: No permit identified for this crossing. FIELD_STRUCT_DESC: 16-inch polyvinyl chloride (PVC) irrigation pipe through the levee, 6 feet below the crown. Headwall on the landside (LS) toe. FS Date: 9/17/2013

Concrete headwall at outlet on LS toe.

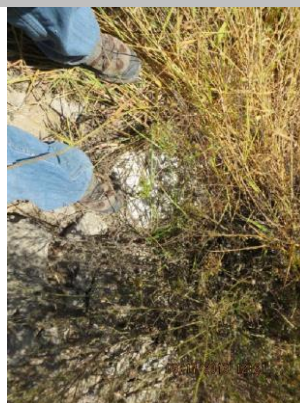
Photo 3 of 3 : UCIP\_FA\_2019\_22872\_39034.jpg

LM Start	4.70	Rating **	M	Issue No.	976 (cont)	
LM End	4.70	Issue Type +	En	Location *		
Category	Supplemental			GPS Latitude/Longitude		
				Start	End	
Item	DRAFT DWR UCIP Field Study			37.630815 °	37.630815 °	
				-121.182416 °	-121.182416 °	
DWR ID	24676					
Comment Code						
Inspector Comment						
DS_ID:24676						
FS_ID:22872						
EP_NO: N/A						
Repair Type: Non-Urgent						
Crossing Status: Found						
UCIP Comments: No permit identified for this crossing.						
FIELD_STRUCT_DESC: 16-inch polyvinyl chloride (PVC) irrigation pipe through the levee, 6 feet below the crown. Headwall on the landside (LS) toe.						
FS Date: 9/17/2013

PVC pipe partially visible on WS toe.

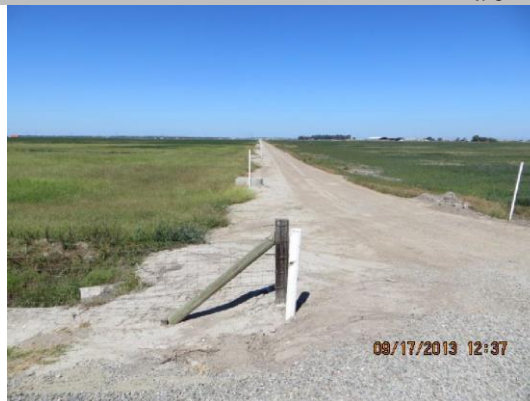
Photo 1 of 2 : UCIP\_FA\_2019\_22873\_39038.jpg

LM Start	5.63	Rating **	M	Issue No.	977
LM End	5.63	Issue Type +	En	Location *	
Category	Supplemental			GPS Latitude/Longitude	
				Start	End
Item	DRAFT DWR UCIP Field Study			37.630779°	37.630779°
				-121.165402°	-121.165402°
DWR ID	24677				
Comment Code					
Inspector Comment					
DS_ID:24677					
FS_ID:22873					
EP_NO: N/A					
Repair Type: Non-Urgent					
Crossing Status: Found					
UCIP Comments: No permit identified for this crossing.					
FIELD_STRUCT_DESC: 24-inch polyvinyl chloride (PVC) irrigation pipe through the levee, 5 feet below the crown. Slide gate at the waterside (WS) shoulder. 6-inch steel riser on the WS shoulder.					
FS Date: 9/17/2013

Concrete turnouts visible off LS toe along road.

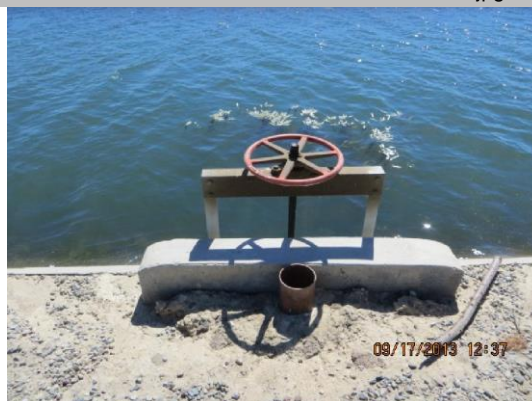
Photo 2 of 2 : UCIP\_FA\_2019\_22873\_39037.jpg

LM Start	5.63	Rating **	M	Issue No.	977 (cont)	
LM End	5.63	Issue Type +	En	Location *		
Category	Supplemental			GPS Latitude/Longitude		
				Start	End	
Item	DRAFT DWR UCIP Field Study			37.630779 °	37.630779 °	
				-121.165402 °	-121.165402 °	
DWR ID	24677					
Comment Code						
Inspector Comment						
DS_ID:24677						
FS_ID:22873						
EP_NO: N/A						
Repair Type: Non-Urgent						
Crossing Status: Found						
UCIP Comments: No permit identified for this crossing.						
FIELD_STRUCT_DESC: 24-inch polyvinyl chloride (PVC) irrigation pipe through the levee, 5 feet below the crown. Slide gate at the waterside (WS) shoulder. 6-inch steel riser on the WS shoulder.						
FS Date: 9/17/2013

Slide gate and vent at concrete headwall on canal at WS shoulder.

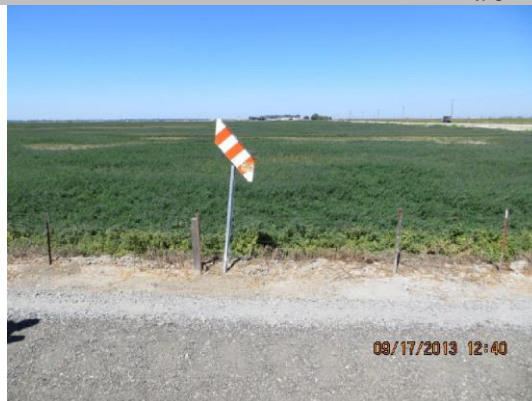
Photo 1 of 2 : UCIP\_FA\_2019\_20745\_34961.jpg

LM Start	5.93	Rating **	M	Issue No.	978
LM End	5.93	Issue Type +	En	Location *	
Category	Supplemental			GPS Latitude/Longitude	
				Start	End
Item	DRAFT DWR UCIP Field Study			37.630760 °	37.630760 °
				-121.159951 °	-121.159951 °
DWR ID	20503				
Comment Code					
Inspector Comment					
DS_ID:20503 FS_ID:20745 EP_NO: N/A Repair Type: Non-Urgent Crossing Status: Found UCIP Comments: Gasline may not have enough cover. FIELD_STRUCT_DESC: 8-inch gas line of an unknown material through the levee, 1 foot below the crown. Sign on the landside (LS) toe. Pipe visible at canal. [Additional Reference(s): DWR Levee Log, 2005. USACE San Joaquin O&M Manual 4, June 1968, (HLM 5.99)]. FS Date: 9/17/2013

Gasline marker on LS toe.

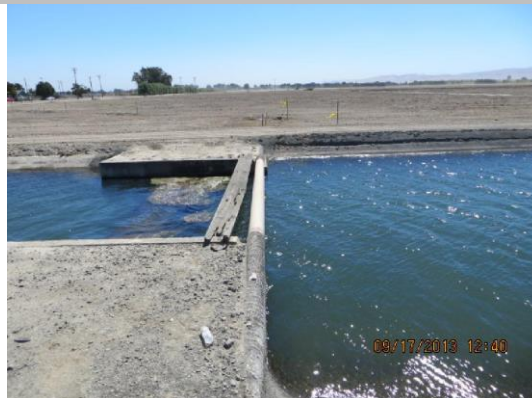
Photo 2 of 2 : UCIP\_FA\_2019\_20745\_34960.jpg

LM Start	5.93	Rating **	M	Issue No.	978 (cont)	
LM End	5.93	Issue Type +	En	Location *		
Category	Supplemental			GPS Latitude/Longitude		
				Start	End	
Item	DRAFT DWR UCIP Field Study			37.630760 °	37.630760 °	
				-121.159951 °	-121.159951 °	
DWR ID	20503					
Comment Code						
Inspector Comment						
DS_ID:20503 FS_ID:20745 EP_NO: N/A Repair Type: Non-Urgent Crossing Status: Found UCIP Comments: Gasline may not have enough cover. FIELD_STRUCT_DESC: 8-inch gas line of an unknown material through the levee, 1 foot below the crown. Sign on the landside (LS) toe. Pipe visible at canal. [Additional Reference(s): DWR Levee Log, 2005. USACE San Joaquin O&M Manual 4, June 1968, (HLM 5.99)]. FS Date: 9/17/2013

Gasline visible at crossing.
